**SAS Superstructure**

Daily Diary Report by Bid Item

Diary #: 362 Const Calendar Day: 72 Date: 15-Aug-2012 Wednesday

**04-0120F4
04-SF-80-13.2/13.9
Self-Anchored
Suspension Bridge****Weather**

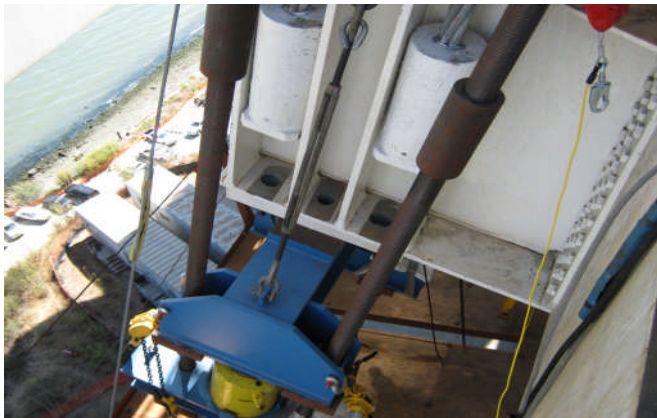
- From 16:00 until 16:30, I did an inventory of each of the suspender brackets along the South cable to check for areas on the bottom flanges under the shims (not yet installed) that have received a finish coat of paint. Warren Collins wanted these areas checked because they may be a bearing surface, & therefore be prime coated only. The PPs where the bottom flanges near the anchor rod holes were finish coat painted included: PP10S, PP24S, PP52S, PP54S, PP56S, PP62S, & PP66S. See attached photo of one of these areas which is typical of most of those PPs listed above. I emailed this photo & list of PPs to Warren.

Portions of the suspender bracket bottom flanges coated with finish paint
